PROCEEDINGS

DECEMBER, 1951

FINAL FOUNDATION TREATMENT AT HOOVER DAM

By A. Warren Simonds, M. ASCE

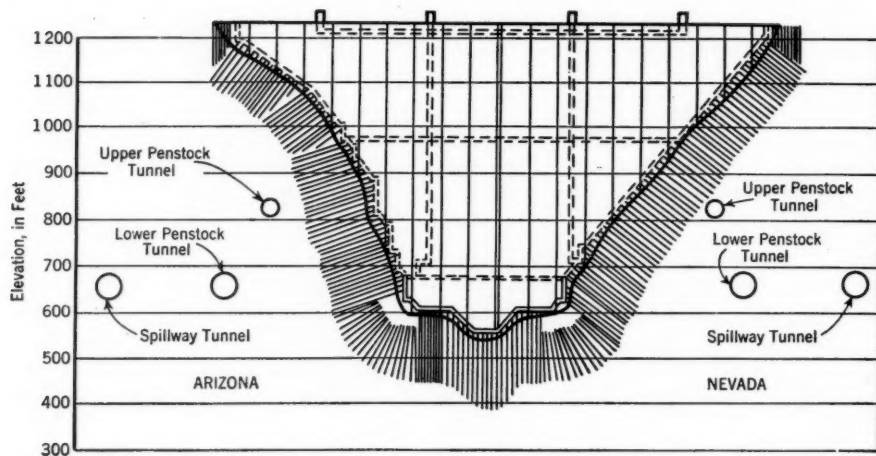
FIG. 2.—PROFILE OF DAM SITE SHOWING PATTERN OF ORIGINAL GROUT CURTAIN

Inadequacy of Original Grouting.—In the original grouting program several complications developed that impaired the effectiveness of the desired water-tight barrier in the foundation and abutments of the dam. The complications consisted of leaks of grout into the abutment joints (described in the following sections) and difficulties resulting from geologic features of the site. The

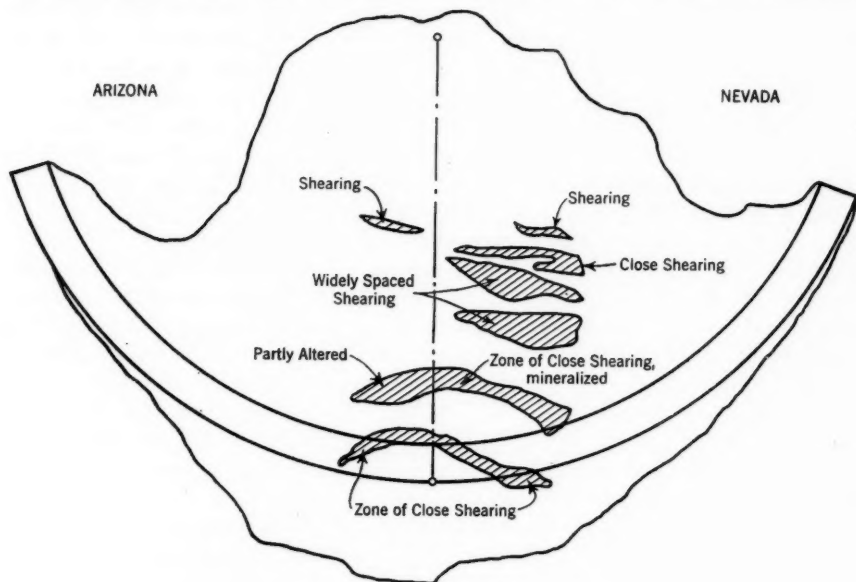
FIG. 4.—SHEARING ZONES IN FOUNDATION

During the construction period, when excavation for the dam had been completed in the river channel area, shallow drainage holes were located in the inner gorge of the excavation and along the bench at El. 600 on the Nevada side of the canyon, wherever seepage or shattered zones were found. The flow from these holes (usually warm water) was piped to the drainage gallery at about El. 555. Later, when the dam was practically finished, an attempt was made to grout these holes. The grouting was ineffective due to premature set of the cement, and the pipe headers, to which the holes had been connected, were plugged. Subsequently the flow from the warm springs apparently filled the zones of close shearing beneath the dam, thereby causing excessive uplift pressure to develop. The location of the shear zones is shown in Fig. 4.

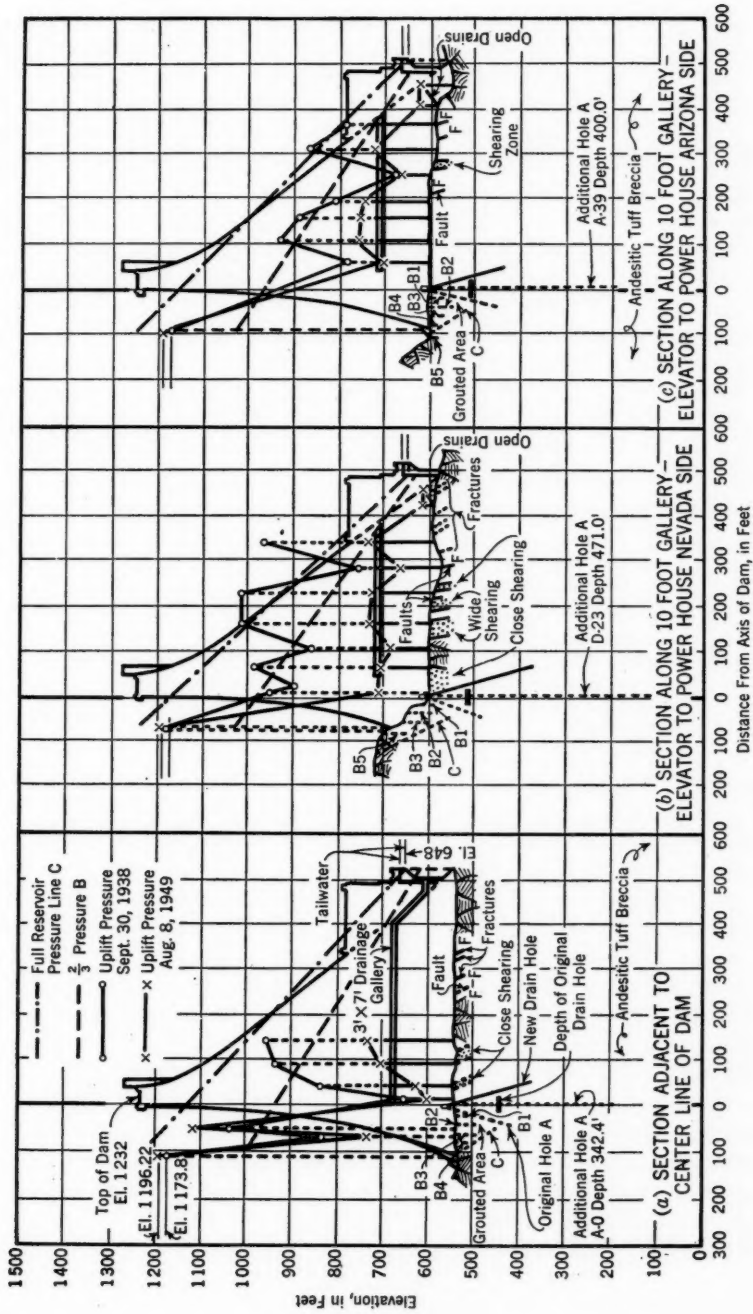
FIG. 6.—UPLIFT PRESSURE GRADIENTS

The maximum uplift pressures at the base of the dam just prior to the time that the additional grouting was started is shown in Figs. 6 and 7. The two-thirds full pressure line (B) and the full reservoir pressure line (C) are shown also in these figures. The worst condition of uplift pressure occurred along the Nevada abutment at line B, in which the magnitude of pressure exceeded that of the full reservoir pressure line (C). At the time of this measurement (September 30, 1938) the reservoir water surface was at El. 1178.8. It had been noted that the ratio of the uplift pressures to the reservoir pressures had been increasing after each annual rise in reservoir level, and it was considered essential to correct this undesirable condition.

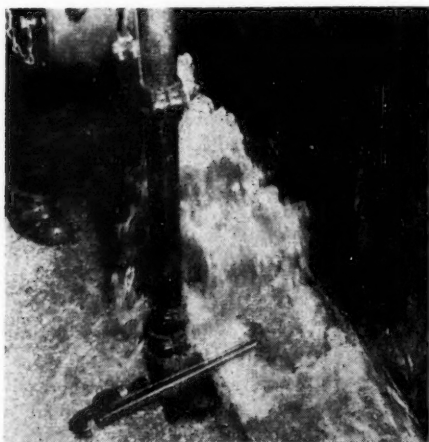
FIG. 8.—FLOW OF WATER FROM FOUNDATION
GROUT HOLE

As the drilling progressed, areas of broken rock shear zones, lenses of uncemented volcanic sand, and open seams that produced large flows of water, such as that shown in Fig. 8, were encountered. Each hole had individual characteristics, and every sack of cement injected benefited the foundation. The policy adopted was to drill the new grout holes deep enough to assure that one "run" of drilling (approximately the length of drilling necessary to fill a 5-ft core barrel) was in good sound rock. This was determined by examination of

Steps were immediately taken to correct these defects in the foundation. It was decided to convert all of the original drain holes into a new line of A holes that would form an additional cutoff curtain, and later drill a new drainage system downstream from this second grout curtain. The procedure planned was to wash the soft manganese material from the seams in the foundation using the group of 3 holes at a time to prevent having too large an area of the foundation beneath the 726-ft high dam unsupported. Grouting with packers was tried in this area, but it was unsuccessful because of excessive interconnections between holes, through cracks and seams in the foundation rock.

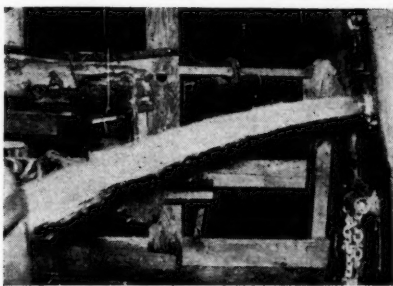
FIG. 10.—FLOW FROM EXPLORATORY HOLE IN NEVADA ABUTMENT

As the program progressed, it became necessary to extend the grout curtain deeper into the Nevada abutment. Deep holes were drilled, first from the Nevada penstock tunnel and then from the spillway tunnel. When drilling to the right of the spillway tunnel, cracks were found that yielded great flows
